# CORROSION

## The Use of Metal Within Masonry Wall Systems and Associated Life-Cycle Issues

By Edward Gerns, RA, LEED AP

This article is reprinted from the Proceedings of RCI's 2009 Building Envelope Technology Symposium in San Diego, CA.

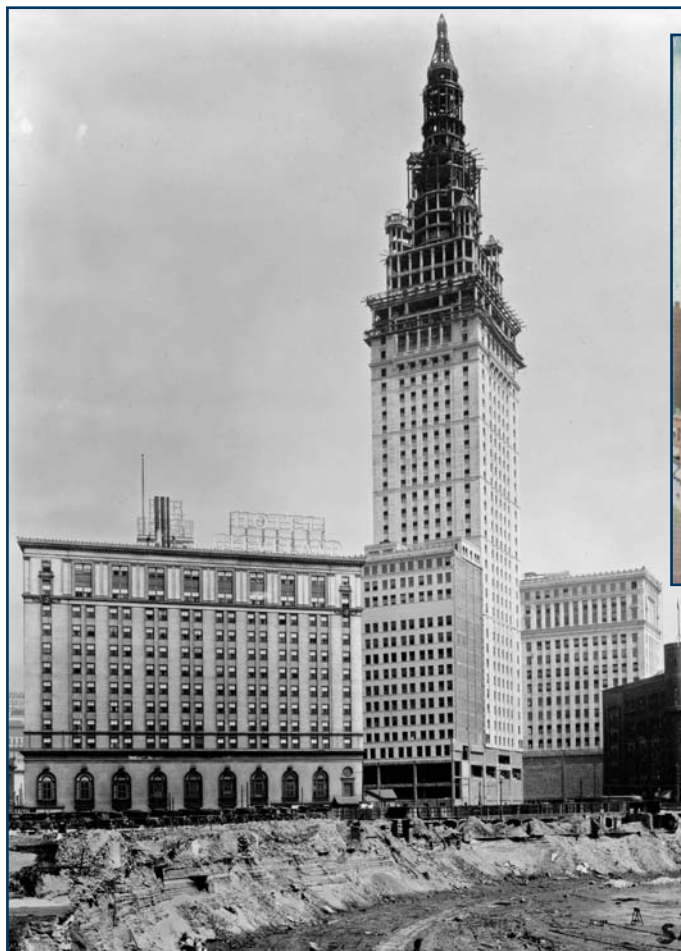
*Figure 1 – Skeleton-frame building under construction (image from [www.skyscrapercity.com](http://www.skyscrapercity.com)).*

The industrial revolution of the late 19th century produced a dramatic change in building construction. The ability to economically manufacture steel shapes led to the development of the skeleton-frame building system. This system enabled the exterior wall to be used as a nonload-bearing component of the building. The façade could be treated as a skin that wrapped the skeletal frame. The skin was still needed to transfer wind loads to the frame and provide weather protection, but it no longer had to support interior floor loads. (See *Figure 1*.)

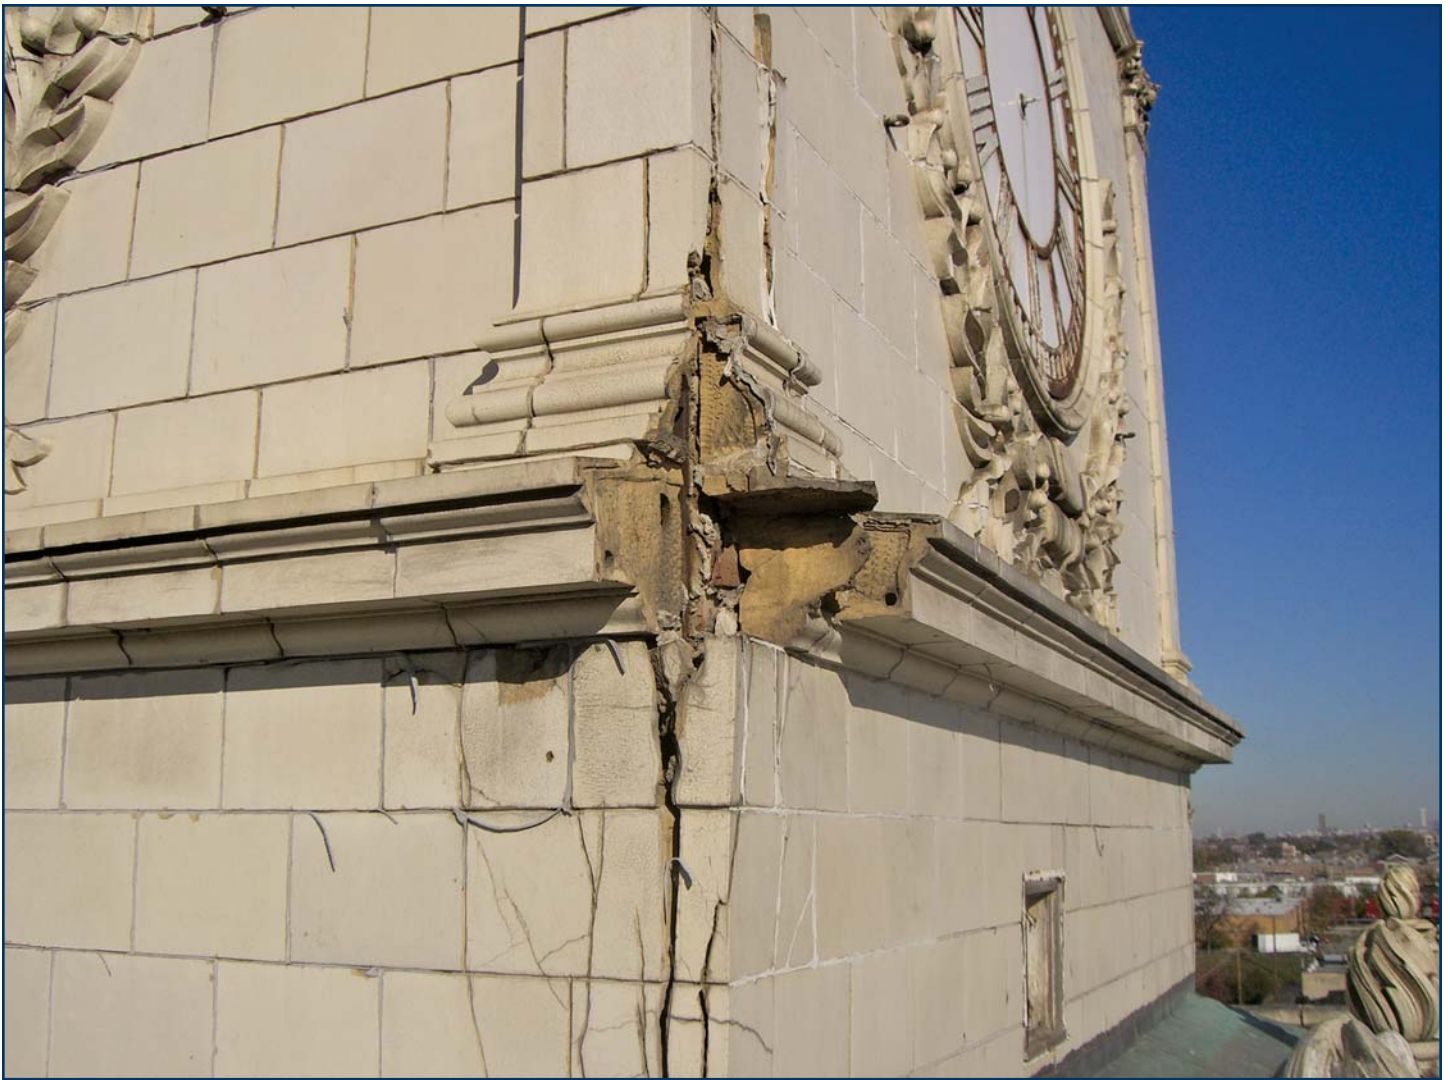
Figure 3 – Distress of masonry cladding resulting from corrosion of embedded steel structure.

The corrosion of exposed iron has long been recognized as a potential problem. The incorporation of iron into masonry construction and subsequent corrosion-related distress have resulted in dramatic changes in the construction and detailing of cladding systems to address water infiltration and corrosion. (See *Figure 3*.)

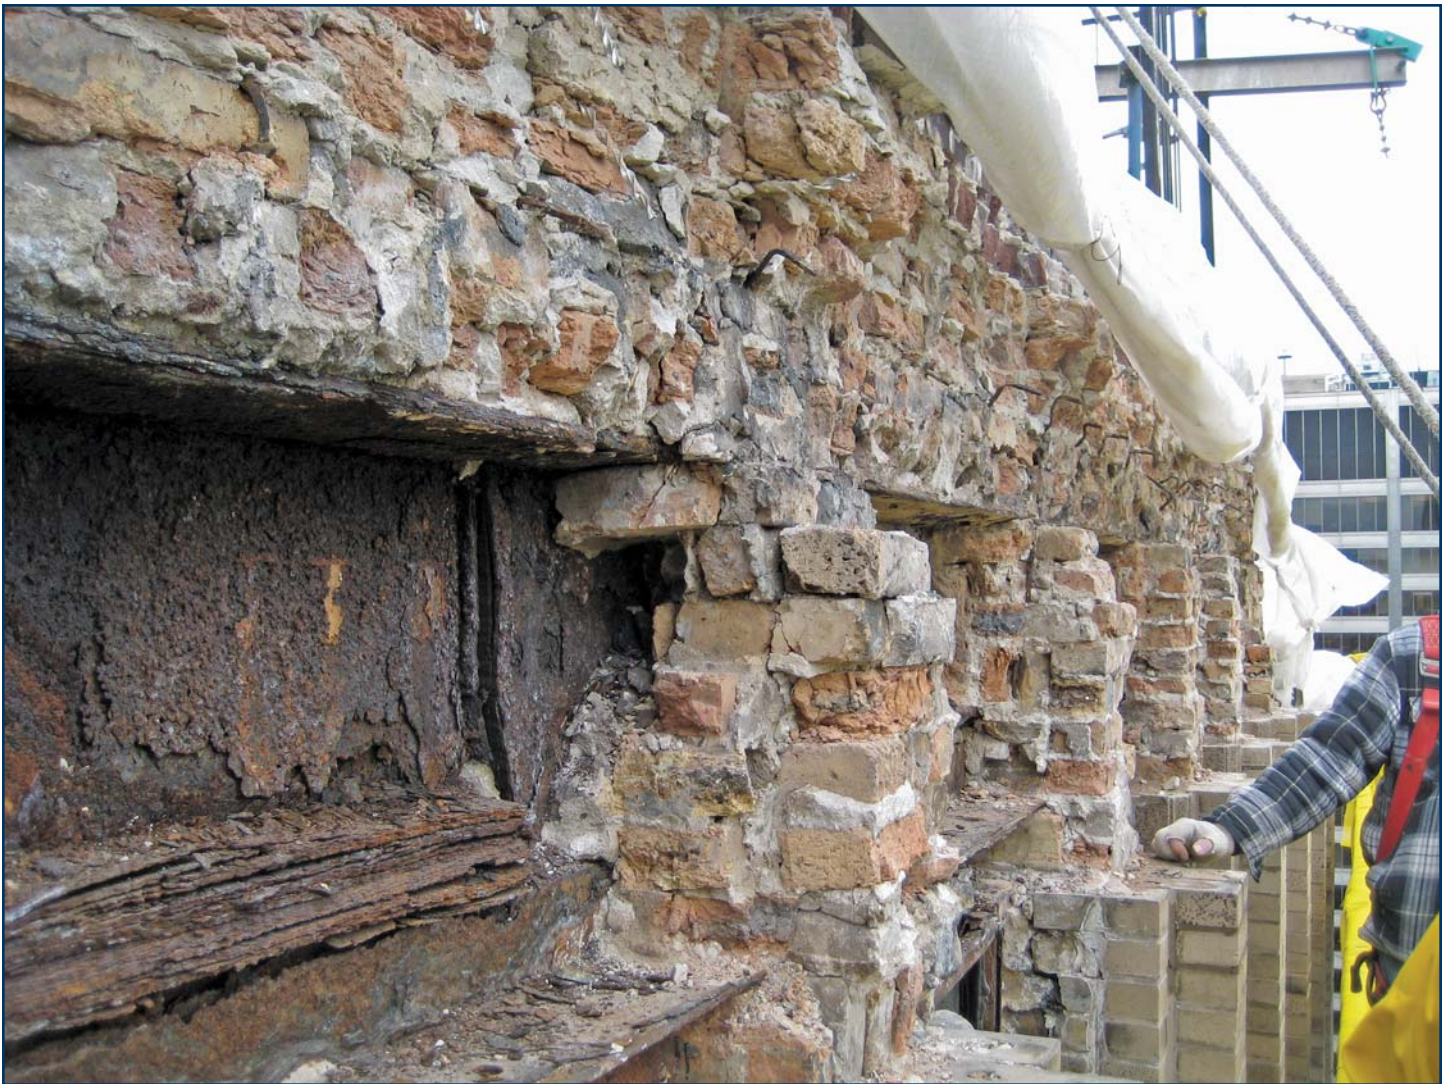
Figure 6 – Corroded steel revealed following removal of terra cotta cladding.

tially constant and relatively low. When the pH falls below four, the rate of corrosion accelerates dramatically. In masonry wall systems, mortar and cement materials initially create an alkaline environment with a pH of approximately ten. As carbon dioxide from the environment penetrates the mortar and causes carbonation, the pH is reduced, resulting in increased corrosion (Craig, 1995). By far the greatest cause of corrosion, however, is water infiltration. (See Figures 6 and 7.)

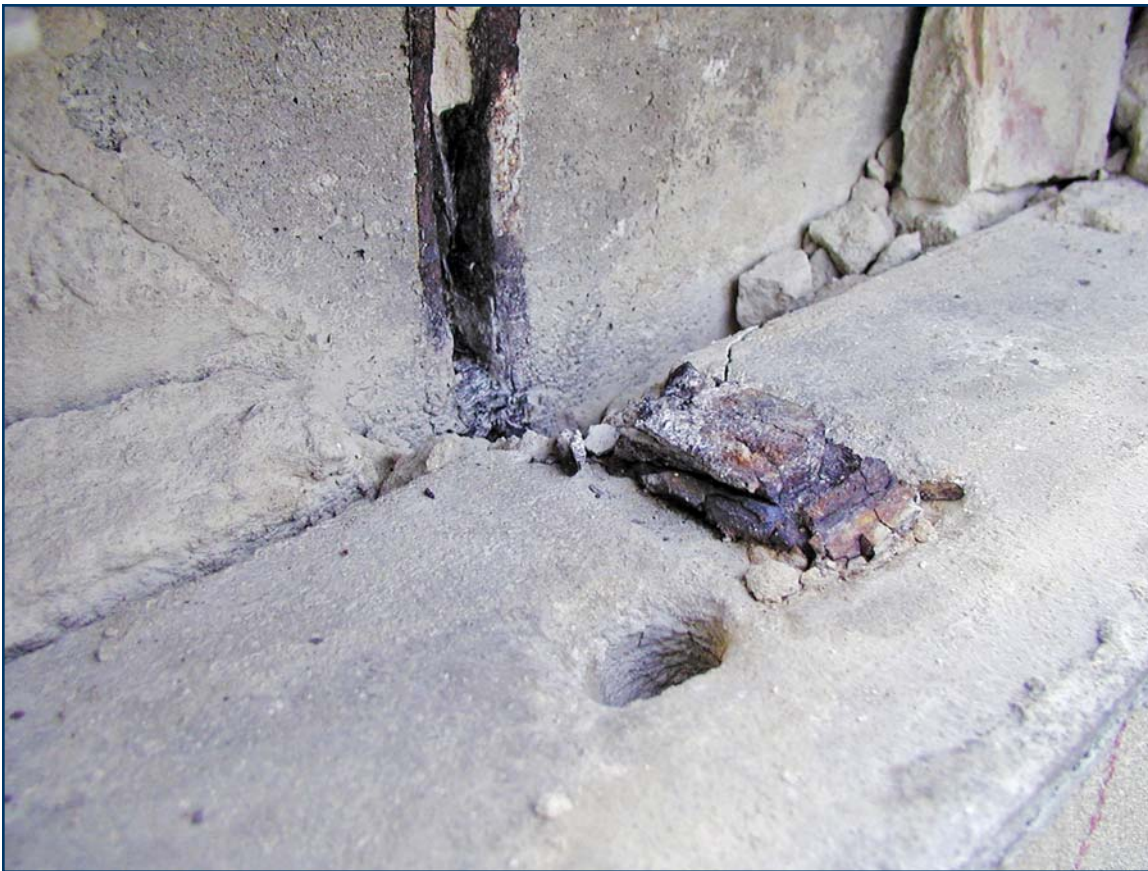
Figure 8 – Complete loss of lateral anchorage.

The deterioration of lateral anchorage within a wall system may be difficult to detect, particularly if the anchors are light-gauge straps that can disintegrate without causing externally visible distress, such as cracking or displacement. The most reliable method for evaluating the condition of these lateral anchors is by direct observation of representative anchors in areas with and without apparent external distress (Figure 8).

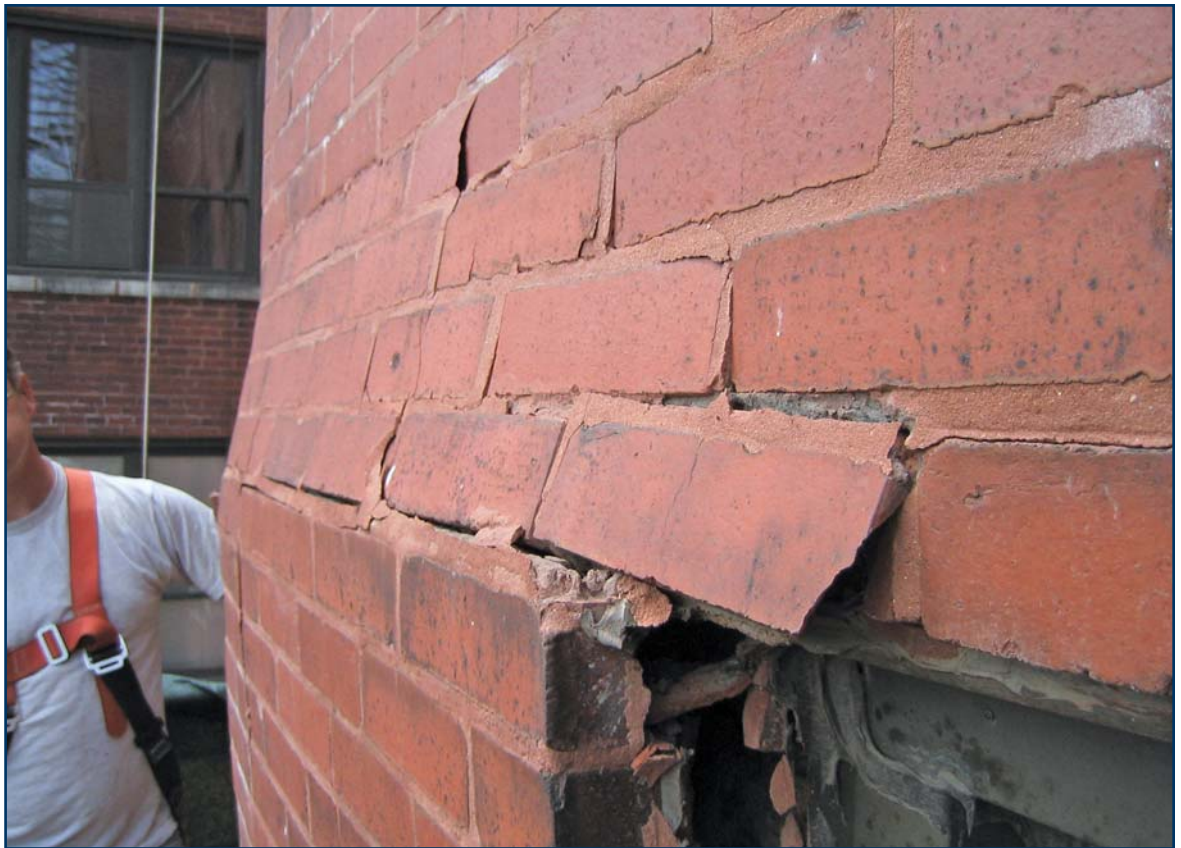
*Figure 9 – Displaced brickwork.*

the displacement of masonry cladding materials (Figure 9).

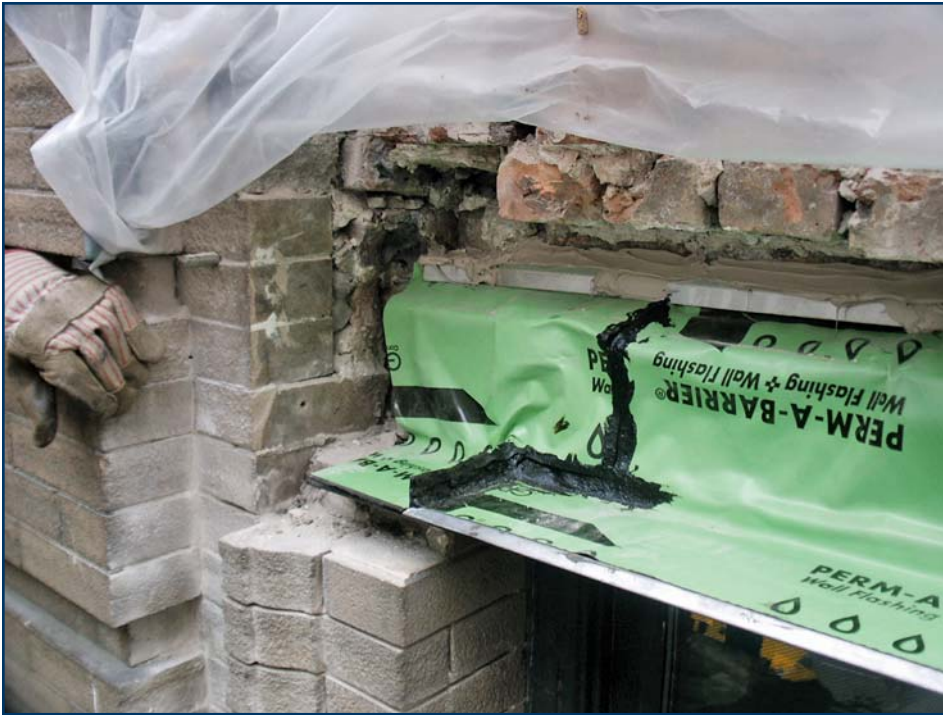
Figure 10 – Installation of flashing system, including end dam to protect underlying shelf angle at window head.

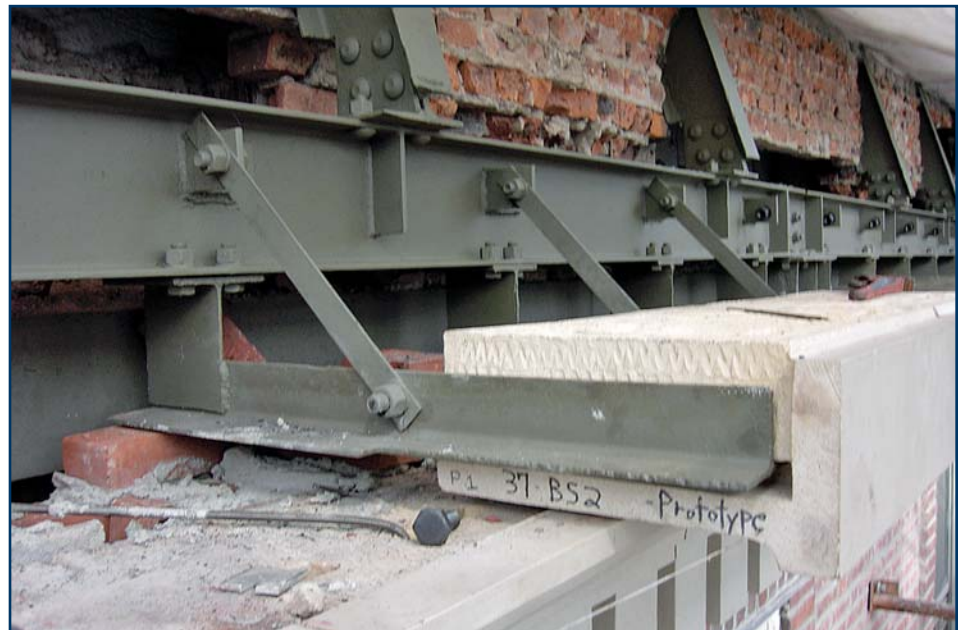
Figure 11 – Coating of existing steel support with corrosion-inhibiting system.

ate corrosion, cleaning and painting of the existing steel with a corrosion-inhibiting system (zinc, urethanes, and epoxies) can be an effective repair (Figure 11). In some cases, severely corroded areas can be widespread or directly adjacent to relatively intact areas, requiring either localized repairs or replacement of the piece.

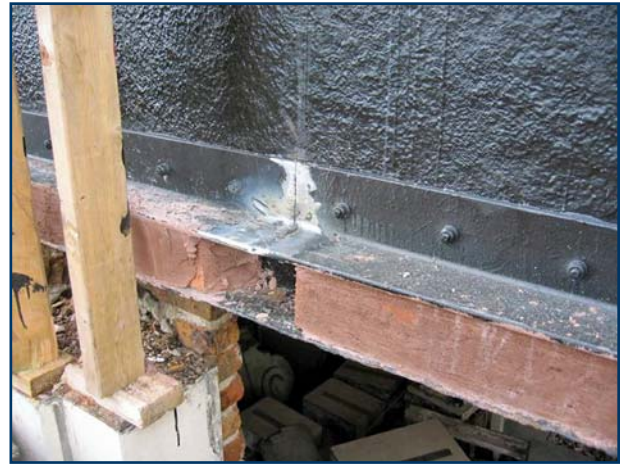
Figure 12A and 12B - Representative example of steel reinforcement.

Bolting of new pieces of steel to existing steel is the most straightforward method of repair (Figures 12A and 12B). This can be expensive, since access necessary to install the nut at the back of the bolt often requires removal of additional backup materials. Several new anchors that are conceptually similar to pop rivets have been introduced within the past decade to permit one-sided installation and eliminate the need to access both sides of the member.
